# The practice of hydrological restoration to rehabilitate abandoned shrimp ponds in Bunaken National Park, North Sulawesi, Indonesia

**Abstract.** *Djamaluddin R, Brown B, Lewis III RR. 2019. The practice of hydrological restoration to rehabilitate abandoned shrimp ponds in Bunaken National Park, North Sulawesi, Indonesia. Biodiversitas 20: 160-170.* The world has lost a large extent of mangroves, while rates of recovery of these ecosystems from natural re-growth and restoration are slow. We developed a hydrological restoration technique to investigate the importance of hydrological modification in mangrove restoration success. Ecological Mangrove Restoration was adopted to restore abandoned shrimp ponds at Tiwoho, Bunaken National Park, North Sulawesi. Hydrological modification resulted in the creation of various mangrove sub-habitat conditions. These conditions remained unstable within the first three years and became relatively stable after seven years. Tidal inundation and soil surface salinity appeared to be the major factors controlling mangrove establishment and growth. All natural recruits and planted trees grew faster and produced more propagules/fruits within a short pe

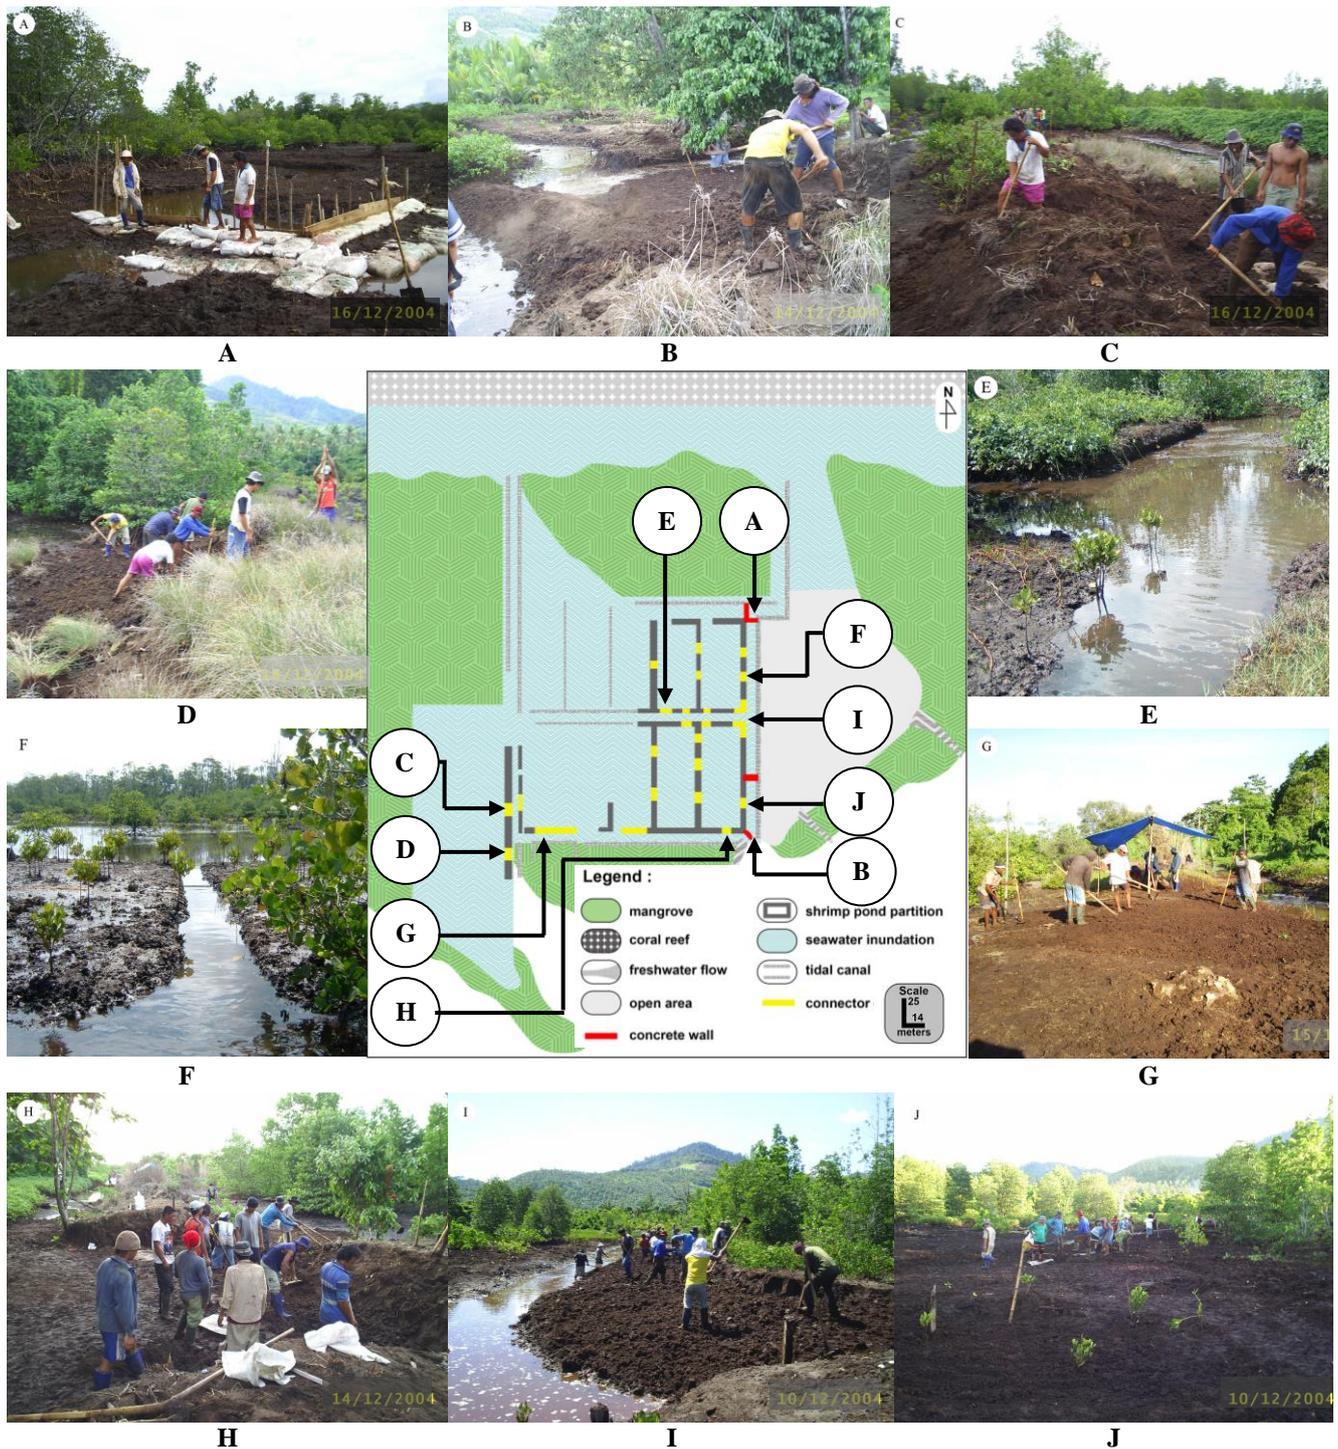
**Figure 3.** Physical changes to restore the hydrological condition

Step 5 was to design the restoration program to initially restore the appropriate hydrology. Data from seawater circulation pattern, level of tidal inundation and site elevation, from step 3 were analysed to develop a hydrological restoration plan for the targeted site. Physical work was conducted between November 2004 to February 2005. The west tidal canal was blocked at three points by means of concrete wall at the base and sand-sacks on the top (Figure 3.A-B). The east canal was not blocked off because the canal had been shallow and its role in

controlling the tidal circulation was not significant. A slight physical change was made to this canal by creating small tidal canals that connected to the main eastern canal to the unvegetated area (Figure 3.C-D). In order to improve access of tidal water to enter areas within the five shrimp pond partitions, a number of small canals were created (Figure 3.E-J).
